Manhole Inspection Summary

Manhole # S35II1013MH

Location Address: **301 HIGHFIELD RD**

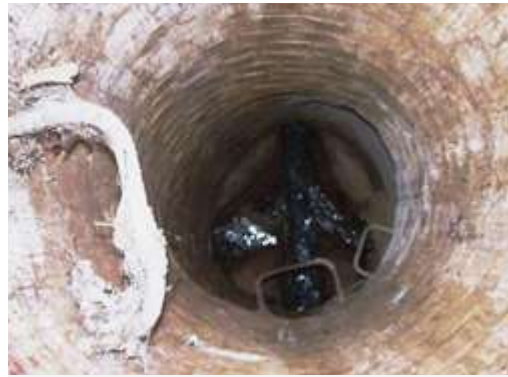
Top View

Corroded and missing steps. Bench debris.

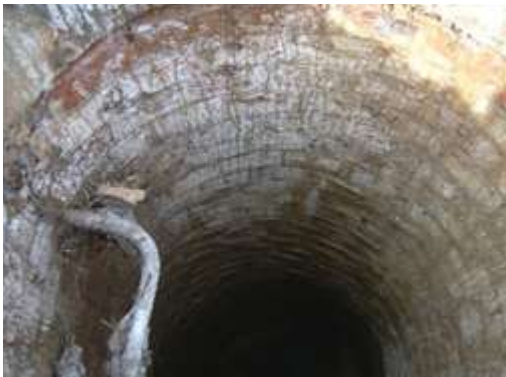
Defect

Adjustment deterioration and infiltration. Corbel and Barrel infiltration - other side.

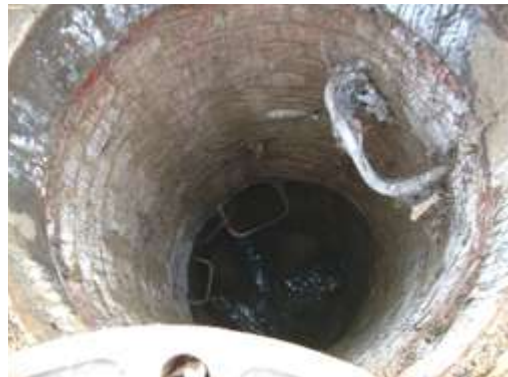
Defect

Adjustment deterioration and infiltration. Corbel and Barrel infiltration.

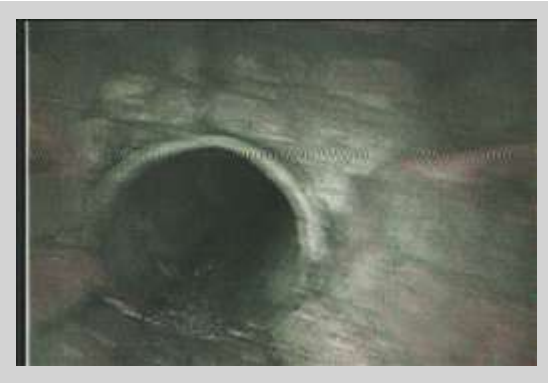
8 in. Circular Gravity Sewer Pipe Out @ 12 O'Clock

Infiltration: **Evidence** Pipe Seal Cond: **Cracked**

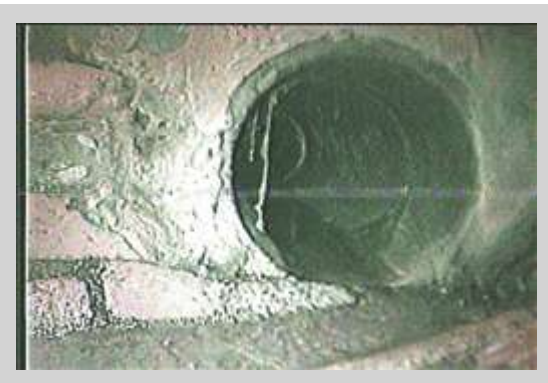
8 in. Circular Gravity Sewer Pipe In @ 3 O'Clock

Infiltration: **Evidence** Pipe Seal Cond: **Unknown**

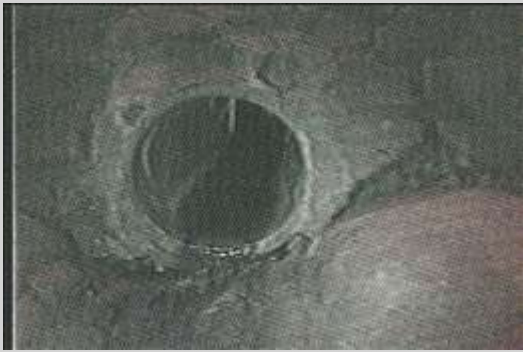
Pipe In @ 6 O'Clock

Infiltration: **Evidence** Pipe Seal Cond: **Cracked**

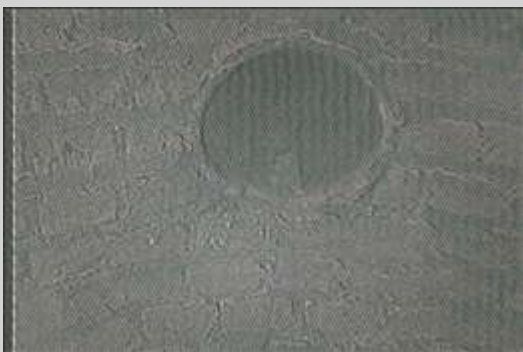
Pipe In @ 9 O'Clock

Barrel deterioration and infiltration.

Deposits: ☐ None ☐ Mud ☐ Sludge ☒ Debris ☒ Grease

Silt Depth: **0.5** (in.) Deposits Extent: **Light**

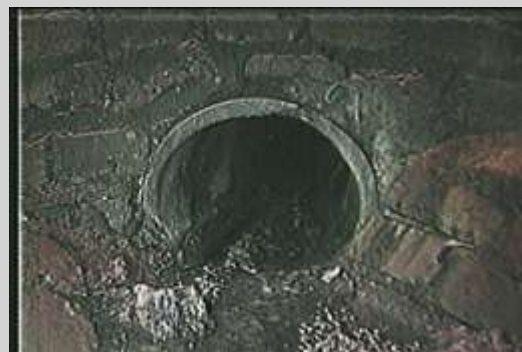
Drop In @ 9 O'Clock

Drop: **Outside** Rod and Bar

Drop Condition: **Open**
